**PERFORMANCE EVALUATION TEST REPORT**

**MADERA PRODUCTS LLC**

**PRODUCT: TimberSIL Lumber Cross Arm Product**

**Report No: A4658.01-106-31**  
**Report Date: 10/29/10**  
**Expiration Date: 10/11/14**

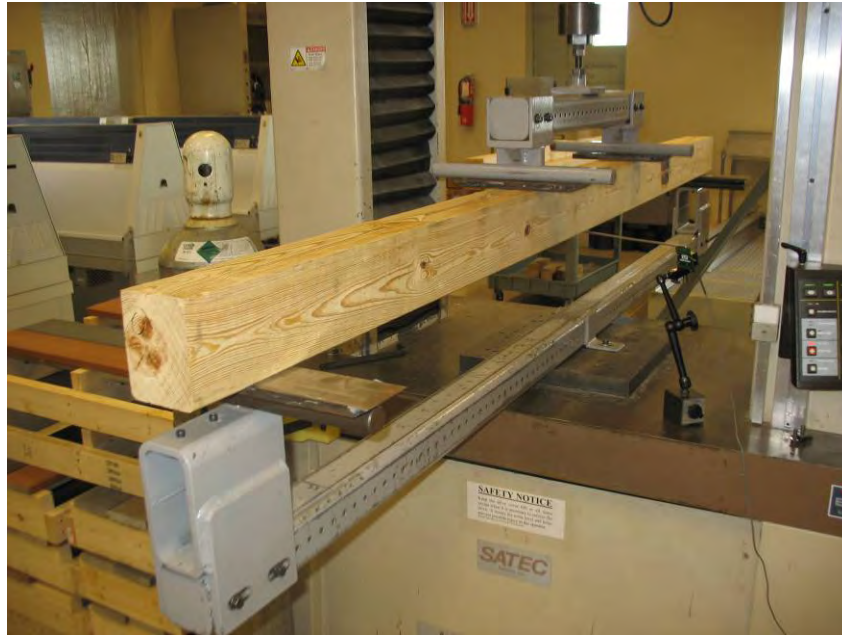
**Photo No. 1**  
**Flexural Evaluation Test Setup**

Five lumber cross arm specimens (nominal dimensions 96.25 in. x 3.50 in. x 4.50 in.) were evaluated for both the control series and TimberSIL test series in accordance with the procedures detailed in ASTM D 198, Section 4. Each specimen was supported with the top face oriented downwards on two 0.5 in. thick, 3.0 in. wide steel bearing plates at a span of 86.0 in. on the test stage of a SATEC 50 UD Universal Testing Machine (ICN Y002011) and compressive load was applied through two 0.5 in. thick, 3.0 in. wide steel bearing plates at a span of 24.0 in. and at a loading rate of 0.75 in/min. Both initial failure load (first localized peak) and ultimate failure load were recorded for calculation of corresponding Modulus of Rupture.

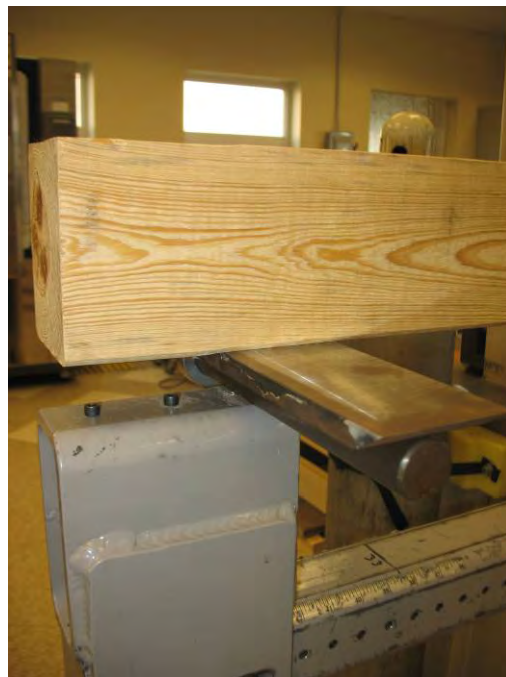
**Photo No. 2**  
**Typical Specimen End Support Detail**

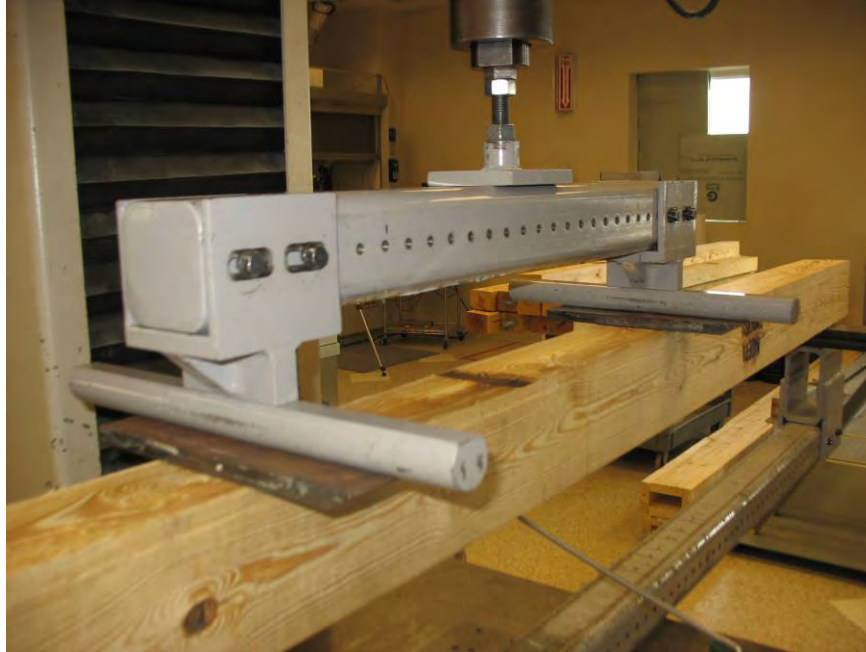
**Photo No. 3**  
**Typical Specimen Loading Detail**

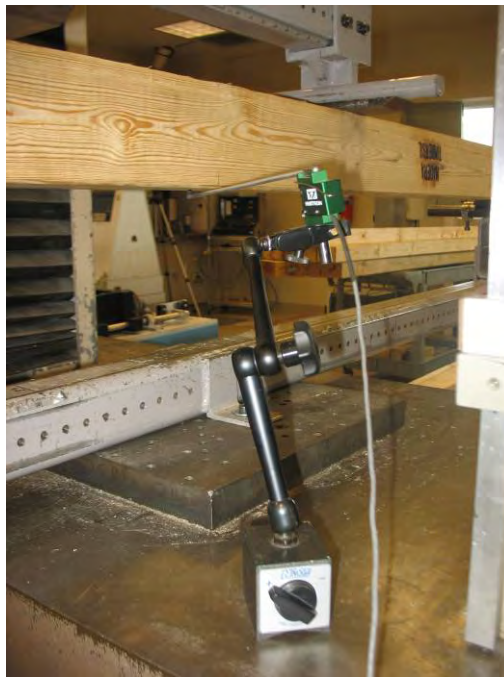
**Photo No. 4**  
**Deflection Measurement Apparatus**

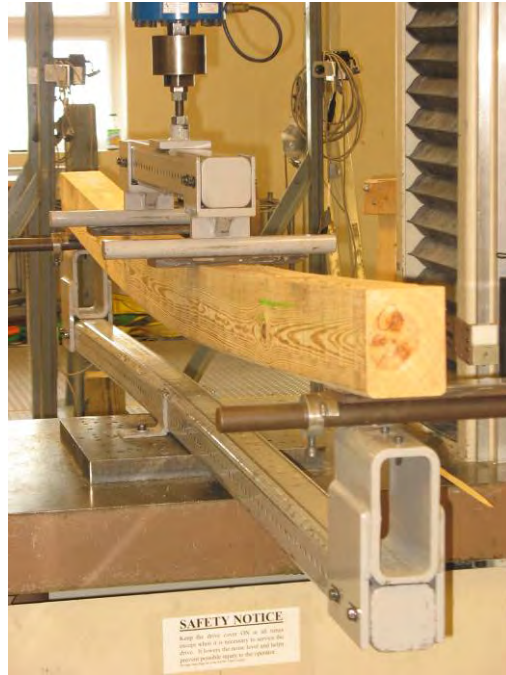
**Photo No. 5**  
**Typical Control Series Specimen at Initial Failure Load**

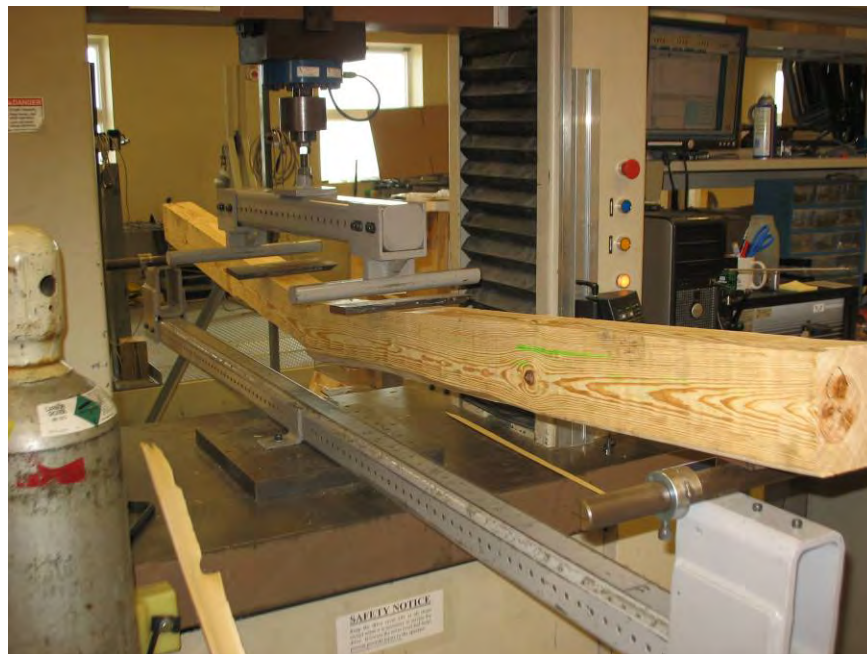
**Photo No. 6**  
**Typical Control Series Specimen at Ultimate Failure Condition**

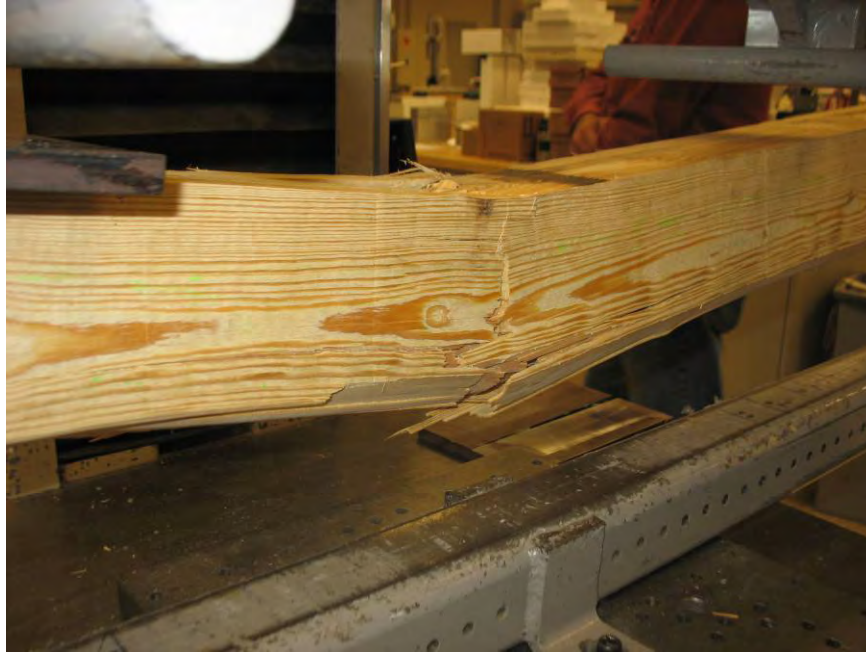
**Photo No. 7**  
**Typical Control Series Specimen at Ultimate Failure Condition Detail**

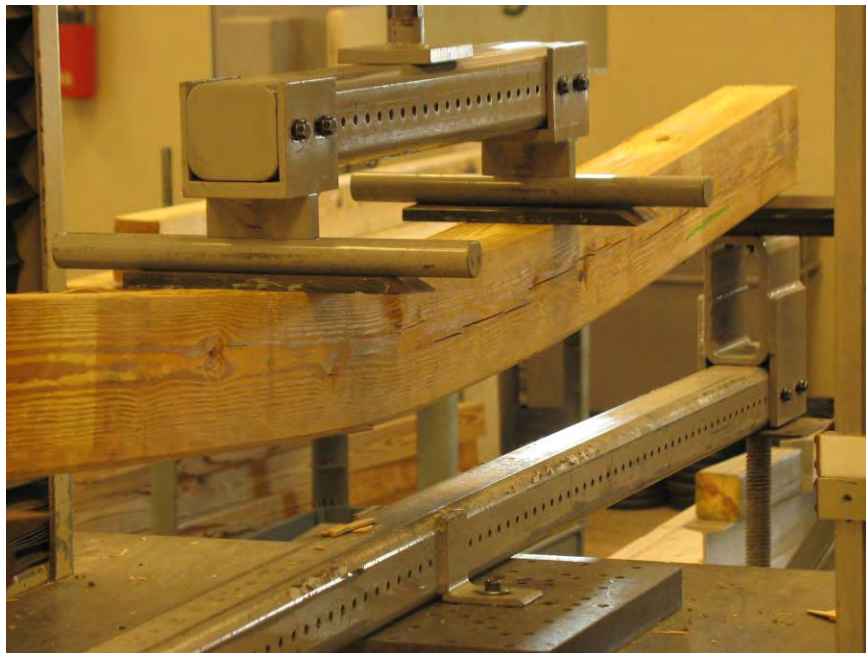
**Photo No. 8**  
**TimberSIL Test Series Specimen at Initial Failure Load**

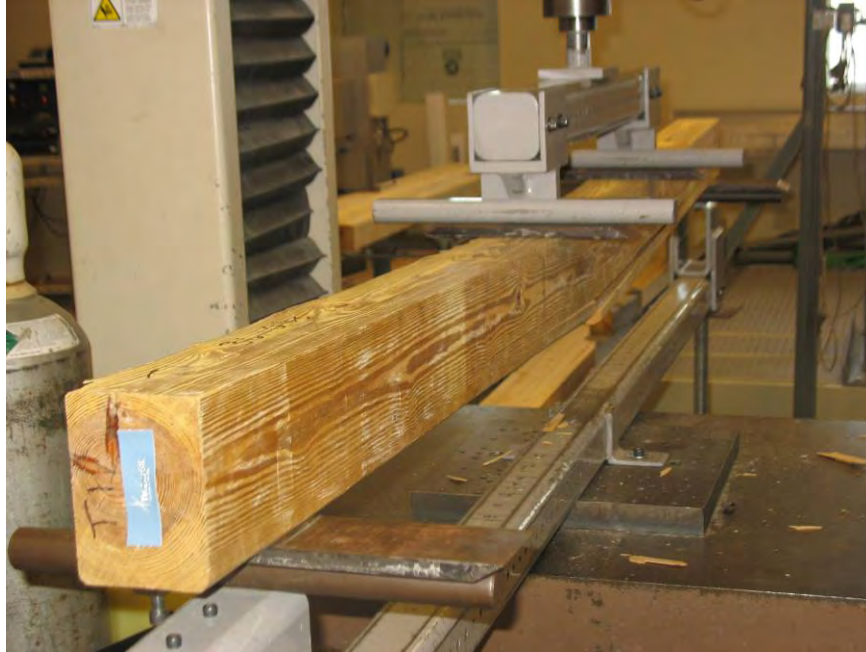
**Photo No. 9**  
**TimberSIL Test Series Specimen at Ultimate Failure Condition**

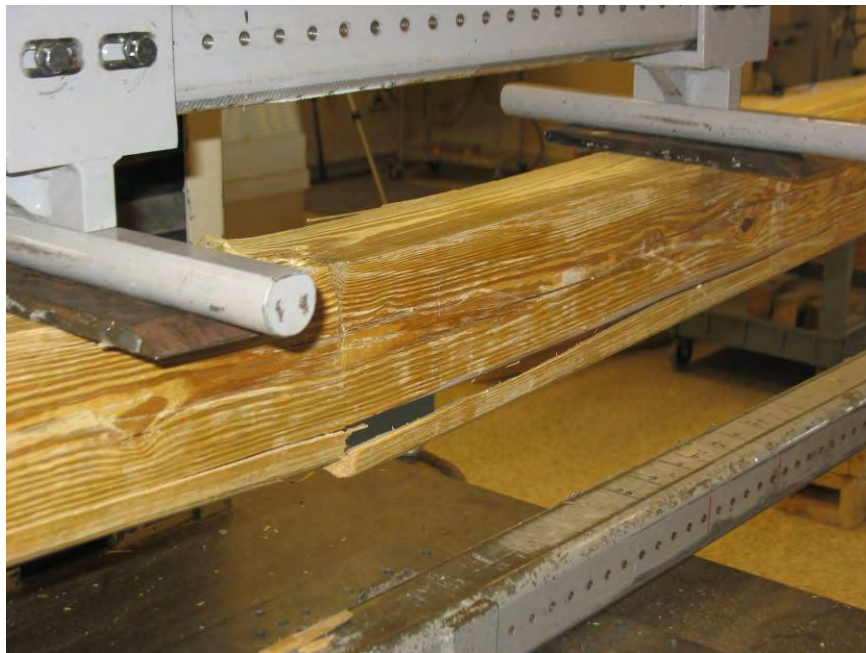
**Photo No. 10**  
**TimberSIL Test Series Specimen at Ultimate Failure Condition Detail**
